**FIGURE 2. LIVING SHORELINE PROJECT PROPOSAL  
CROSS SECTION REFERENCES  
LASSING PARK, PINELLAS COUNTY, FL**

# Lassing Park

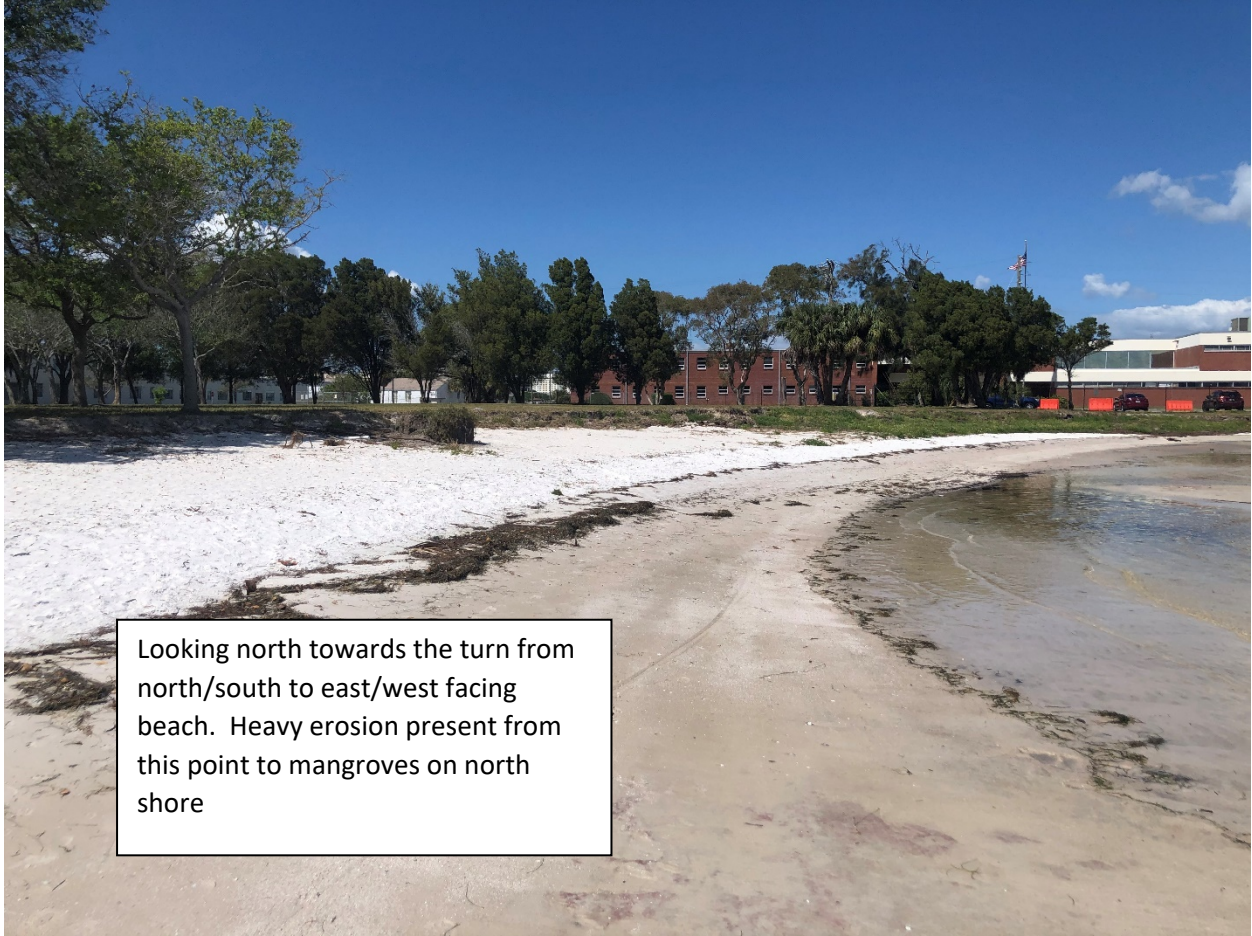
Looking north towards the turn from north/south to east/west facing beach. Heavy erosion present from this point to mangroves on north shore

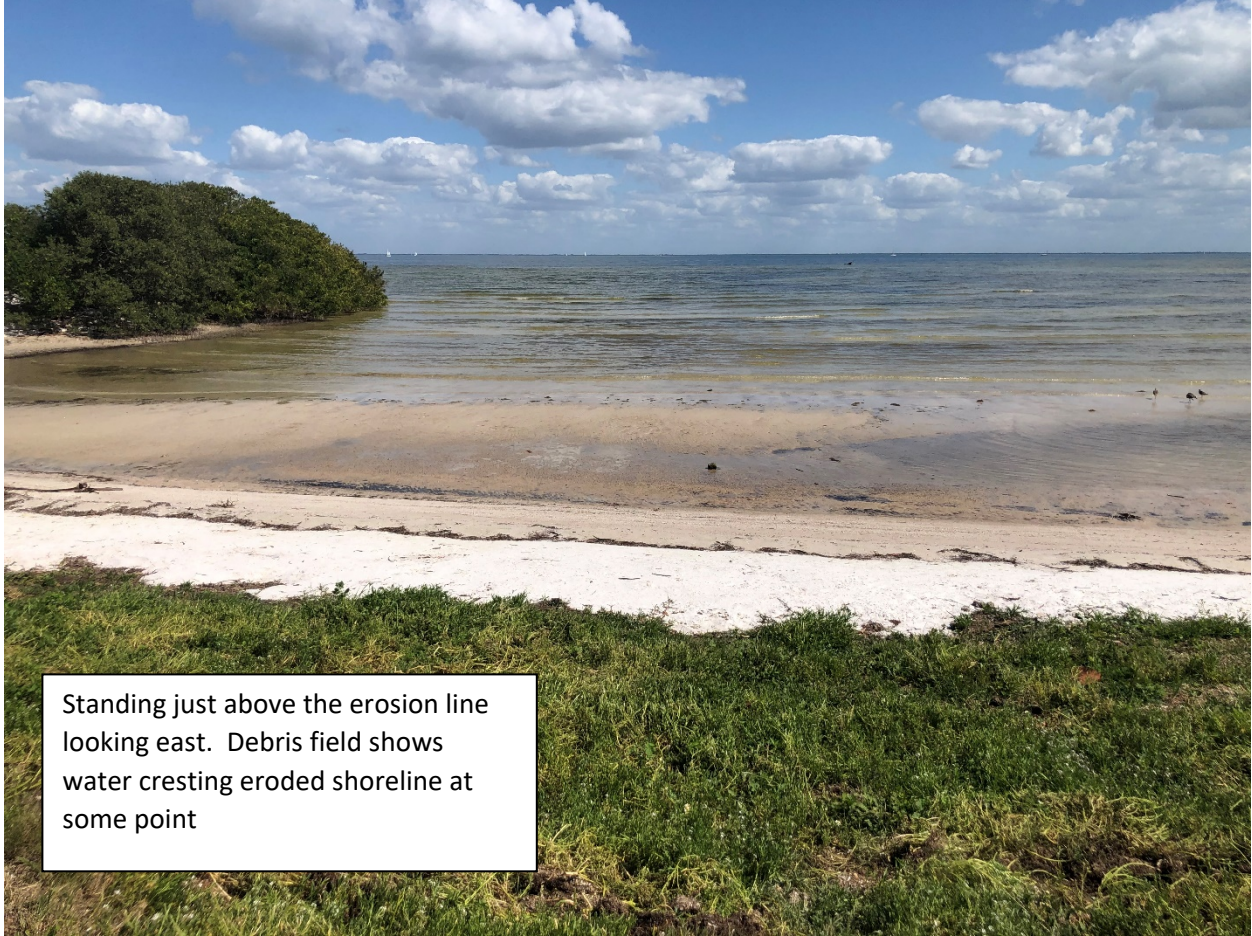
Standing just above the erosion line  
looking east. Debris field shows  
water cresting eroded shoreline at  
some point

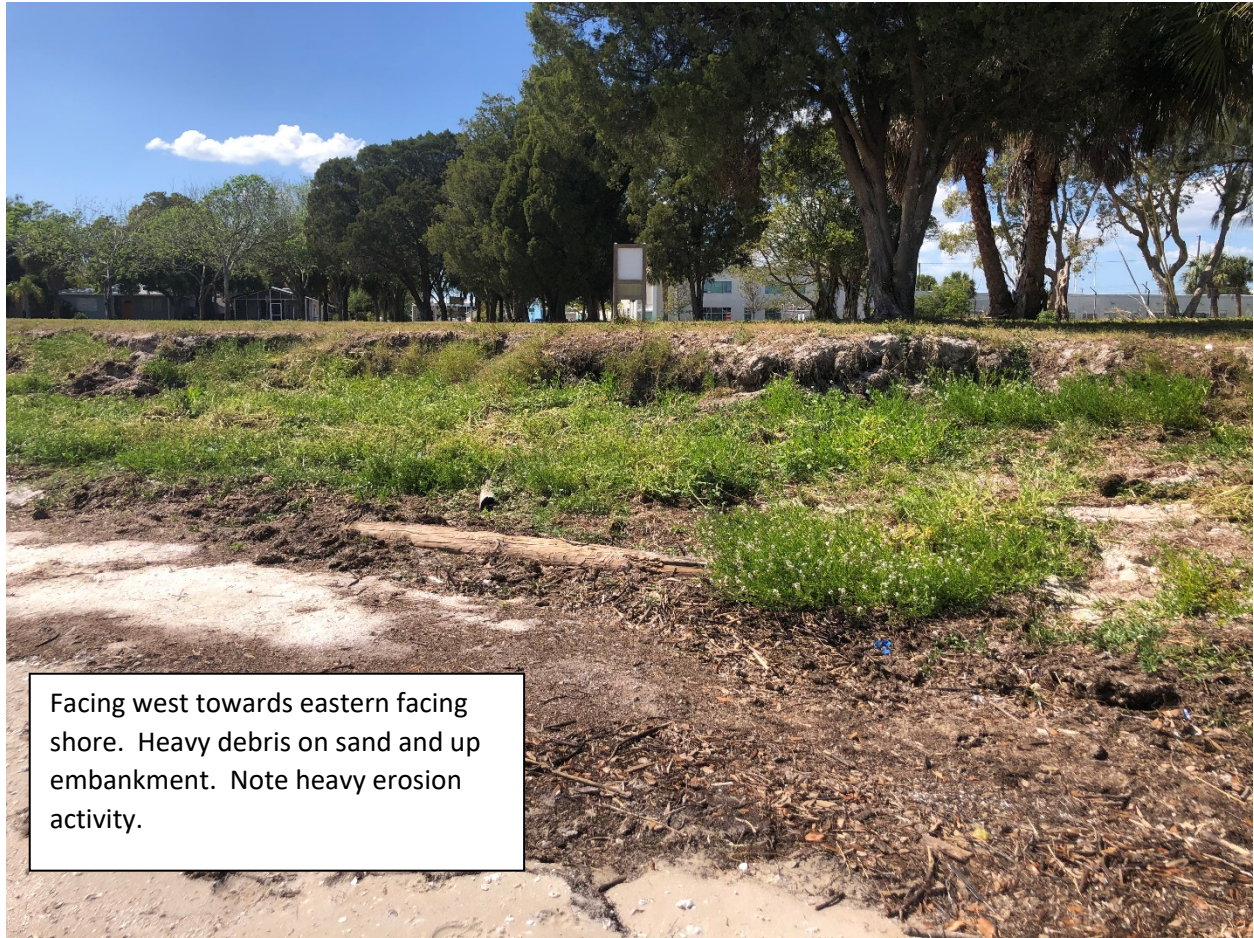
Facing west towards eastern facing shore. Heavy debris on sand and up embankment. Note heavy erosion activity.

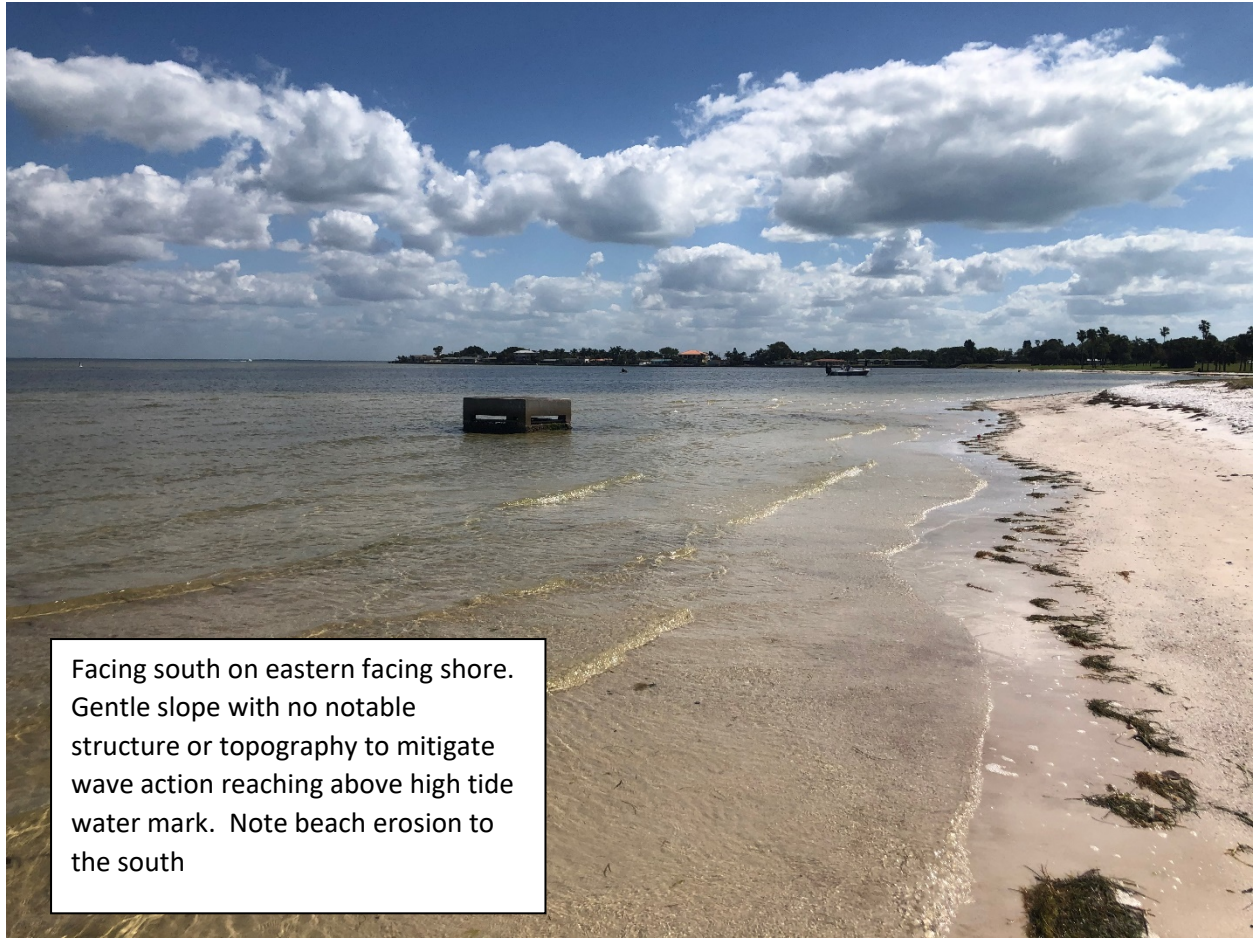
Facing south on eastern facing shore. Gentle slope with no notable structure or topography to mitigate wave action reaching above high tide water mark. Note beach erosion to the south
